**SCREENING SITE INSPECTION REPORT
FOR
BOHATY DRUM SITE
MEDINA COUNTY, OHIO**

U.S. EPA ID No. OHD 987 033 743

EPA Region	:	5
Date Prepared	:	September 19, 1994
Contract No.	:	68-W8-0084
Work Assignment No.	:	29-5JZZ
PRC No.	:	030-002978
Prepared by	:	PRC Environmental Management, Inc. (Kristine Kruk)
PRC Project Manager	:	Julie Kaiser
Telephone No.	:	(703) 556-2585
EPA Work Assignment Manager	:	Jeanne Griffin
Telephone No.	:	(312) 886-3007

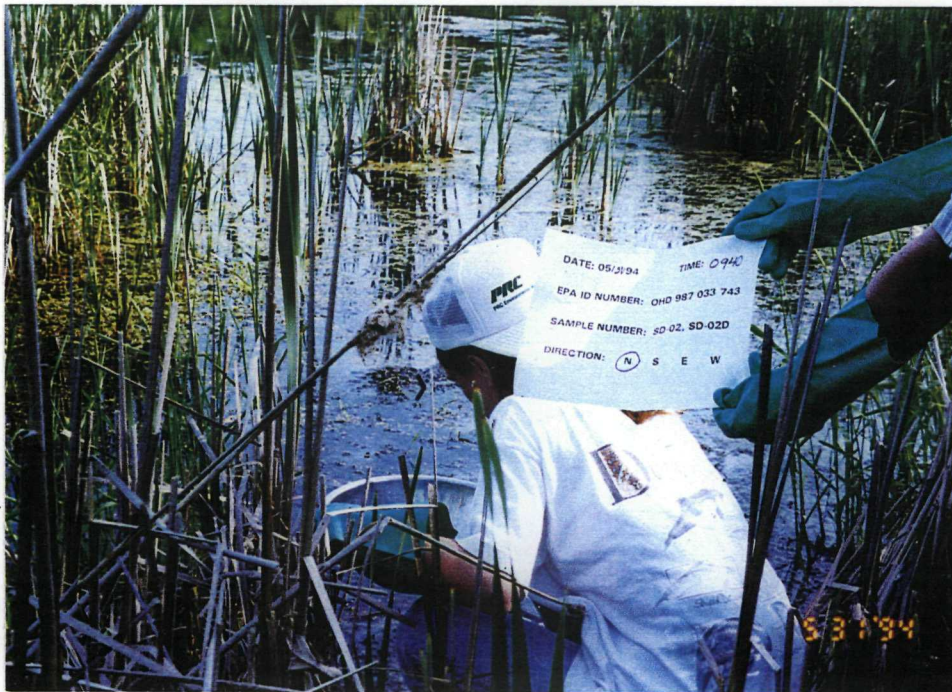
Photograph No. 1

Sampling Location: SD-02 and SD-02D

Description: Sampling in wetlands in the southeastern portion of the on-site pond; note the oily sheen on the surface water in this location

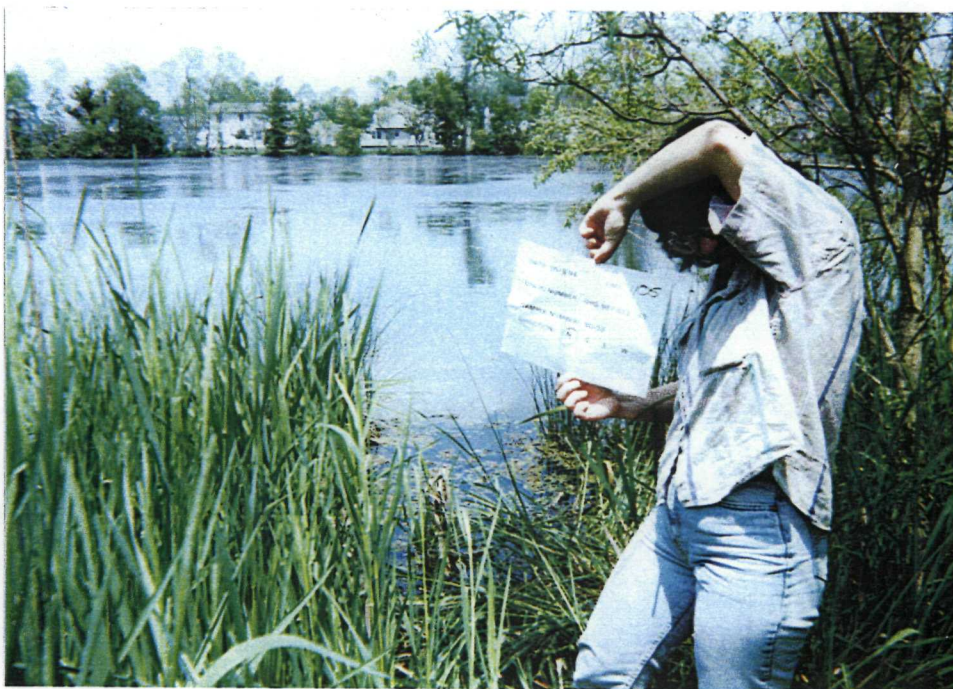
Photograph No. 2

Sampling Location: SD-03

Description: Sampling in wetlands in the southern portion of the on-site pond about 540 feet west of sampling locations SD-02 and SD-02D

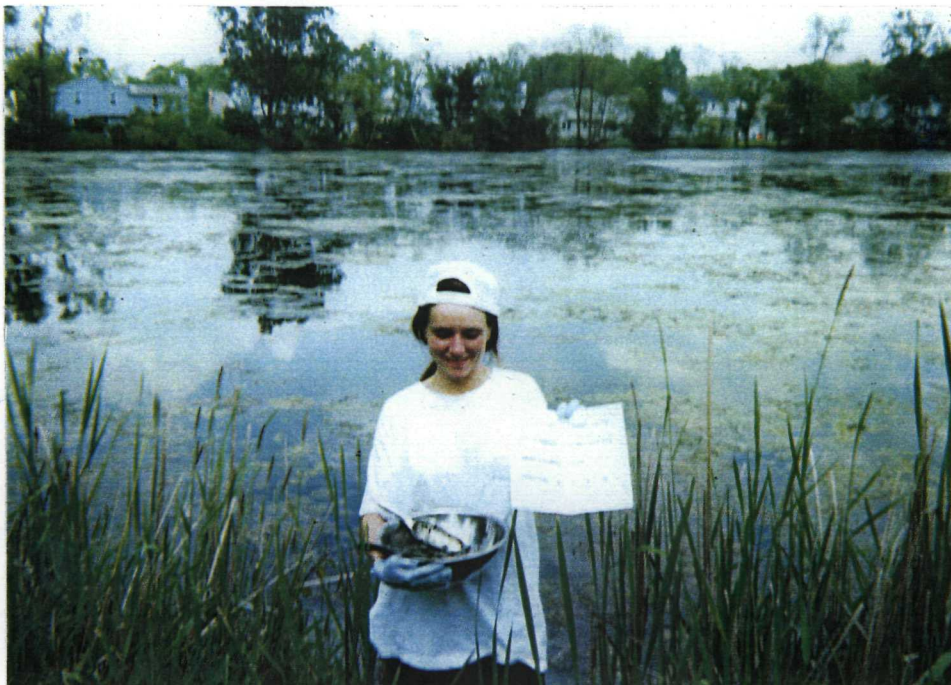
Photograph No. 3

Sampling Location: SD-04

Description: Sampling in wetlands in the southwestern portion of the on-site pond about 150 feet northwest of sampling location SD-03
